NASA/TM—2006-214330

# Foreign Object Damage in a Gas-Turbine Grade Silicon Nitride by Spherical Projectiles of Various Materials

Assessments of foreign object damage (FOD) of a commercial, gas-turbine grade, in situ toughened silicon nitride ceramic (AS800, Honeywell Ceramic Components) were made using four different projectile materials at ambient temperature. AS800 flexure target specimens rigidly supported were impacted at their centers in a velocity range from 50 to 450 m/s by spherical projectiles with a diameter of 1.59 mm. Four different projectile materials were used including hardened steel, annealed steel, silicon nitride ceramic, and brass. Post-impact strength of each target specimen impacted was determined as a function of impact velocity to appraise the severity of local impact damage. For a given impact velocity, the degree of strength degradation was greatest for ceramic balls, least for brass balls, and intermediate for annealed and hardened steel balls. For steel balls, hardened projectiles yielded more significant impact damage than annealed counterparts. The most important material parameter affecting FOD was identified as hardness of projectiles. Impact load

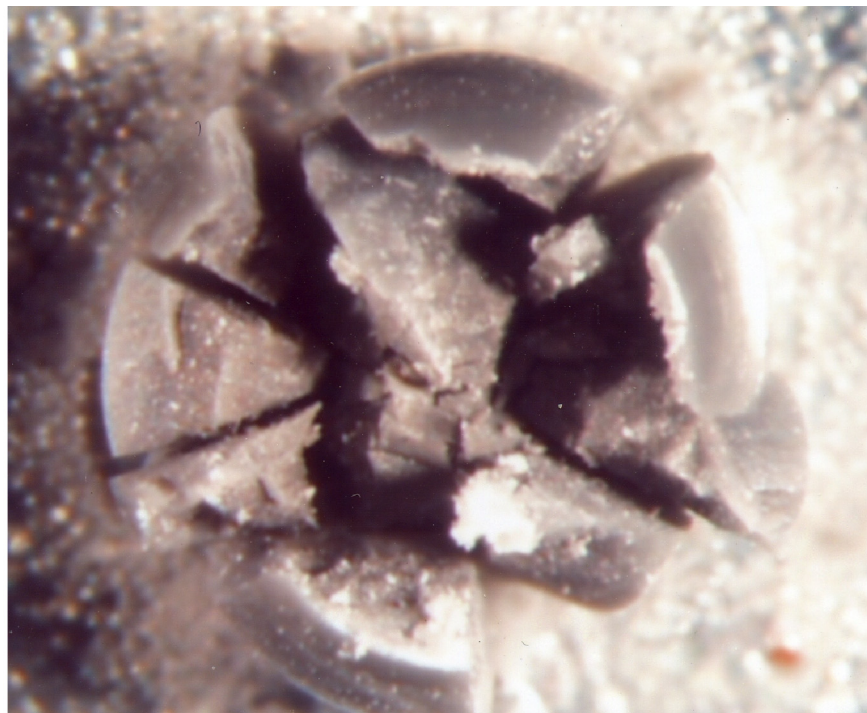
Figure 14.—A typical failure pattern of a 1.59 mm-diameter silicon nitride ball indenter subjected to crushing testing against AS800 silicon nitride flexure specimen; Crushing load = 1690 N.

Fracture of ceramic ball projectiles was typified with several broken fragments in a splitting mode of failure by tensile stress, in principal similar to failure of hardened steel balls. A typical example of a crushed ceramic ball is shown in figure 14. Shape of fragments each representing a wedge toward the center of the ball is indicative of a role of tensile stress in fracture.
